CASE STUDY

PROJECT	REPLACE ROOF WASTE WATER PLANT
PRODUCT	Steel Panel Tank Roof
INDUSTRY	Infrastructure
LOCATION	Western Australia

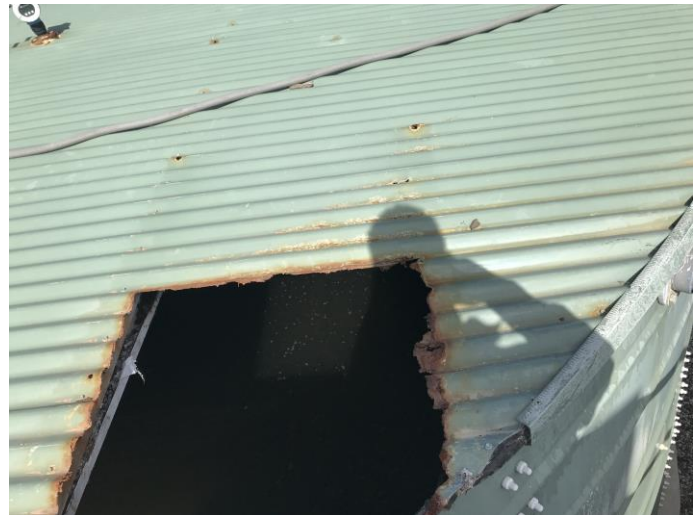
The tank roofs were corroded in the areas where the ventilation system was not effectively removing hydrogen sulphide (H₂S).

The existing roofs had extensive damage

- Galvanised trusses and colourbond roof sheets were blasted and treated with an additional epoxy coating.
- Extended life and greater resistance to corrosion.

- Existing ventilation system was not operating as designed.
- Modify existing system to improve ventilation
- Lower hydrogen sulphide levels as a result of improved air flow reduces long term corrosion.

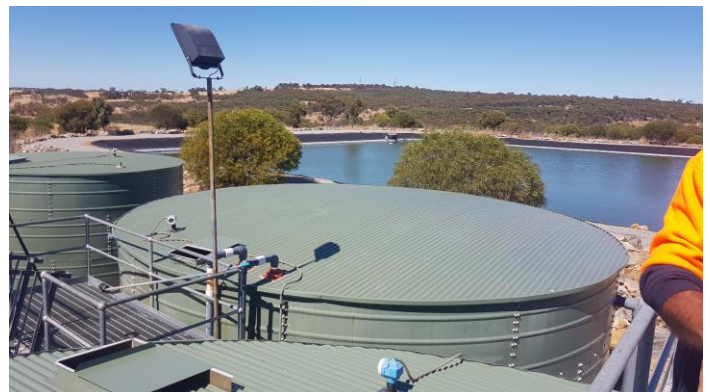
New upgraded colour matched Roofs
