CASE STUDY

PROJECTSOLUTIONS FOR MARINE CONTRACTORPRODUCTGravity Clarifier MaintenanceINDUSTRYInfrastructureLOCATIONMartha Cove, VIC

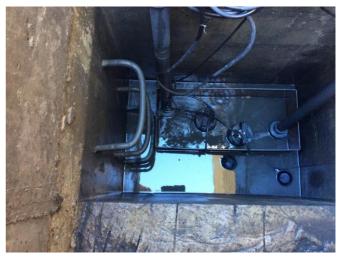
Perforated Mesh Screen in Pump Pit

- Perforated mesh basket was installed to the pump pit acting as a barrier for all sized aggregate that may cause damage to the submerged pump internals
- Mesh was installed to wash bay run off pits to act as a first stage line of defence against stone/solids ingress to pit / drain system
- Any build-up of unwanted solids to pits are scheduled to be vacuumed out periodically as required

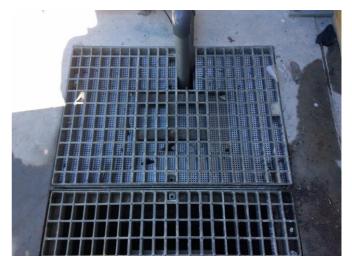
Perforated Mesh Screen at Pit Covers
