CASE STUDY

PROJECT CLARIFIER REPLACEMENT FOR CONTAINER HANDLER

PRODUCT Lamella Clarifier (LC)

LOCATION Port of Brisbane, Queensland

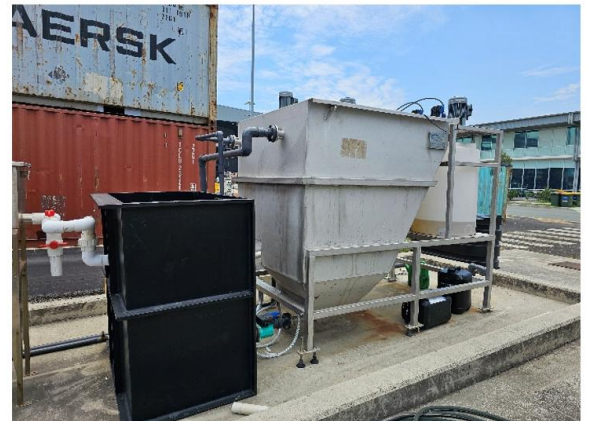
Replacement Clarifier Side View

Replacement Lamella Clarifier, skid mounted – existing equipment and control utilised where possible.

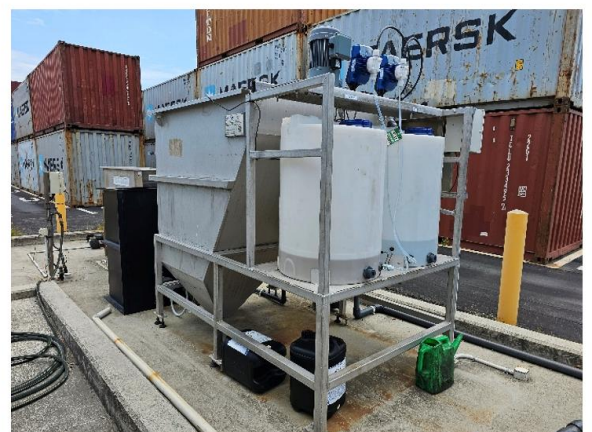
Replacement Clarifier Front View
