CASE STUDY

PROJECT STORMWATER TREATMENT FOR RECYCLING

PRODUCT Lamella Clarifier (LC) and Multimedia Filtration (MMF)

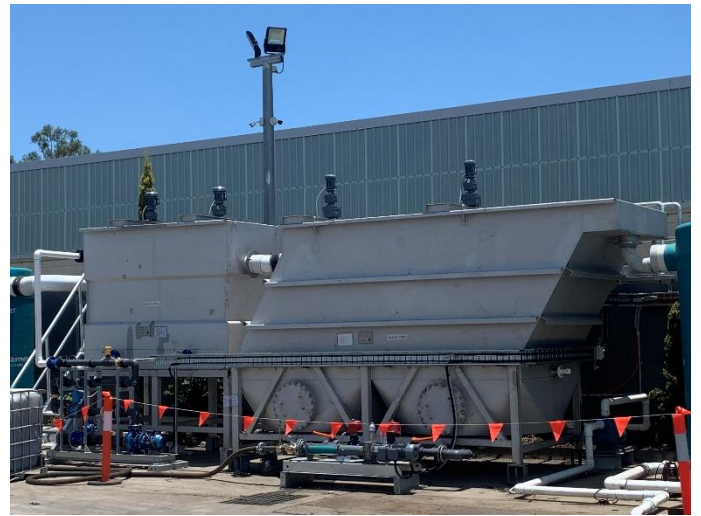
MAK Water Lamella Clarifier installed onsite

- **Pre-treatment:** Implemented an Oil Water Separator (OWS) to effectively reduce oil and grease content.
- **Primary Clarification:** Installed a frame-mounted Lamella Clarifier (LC) to remove solids and reduce heavy metals.
- **Media Filtration:** Utilised a containerised (1 x 40') Multimedia Filtration (MMF) plant for residual solids removal and further heavy metal reduction.
- **Capacity:** Designed for a treatment throughput of 7.0 L/sec (25 m³/hr), ensuring robust site operations

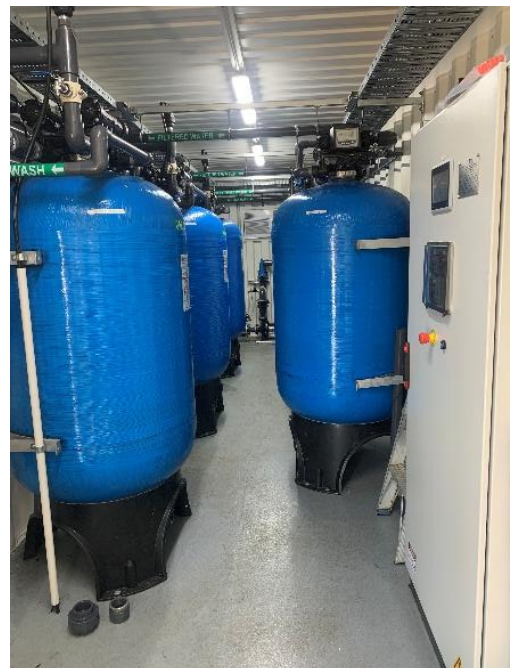
Internal view of the containerised MMF plant
