CASE STUDY

PROJECT BOAT CLUB ODOUR AND RELIABILITY ISSUES

LOCATION Victoria

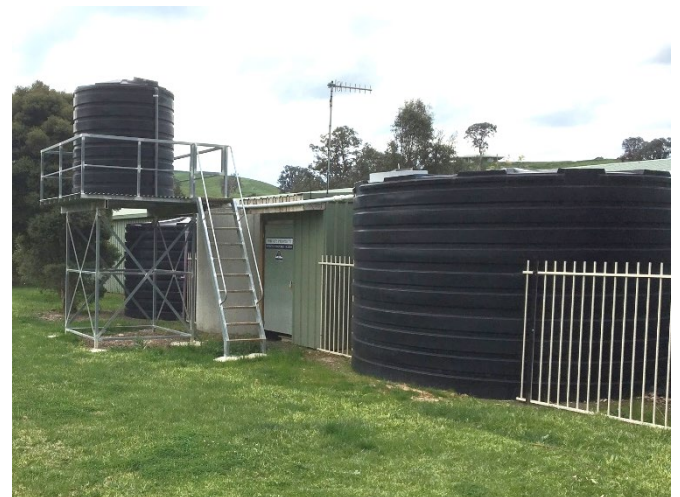
MAK Water containerised SWRO plant installed onsite

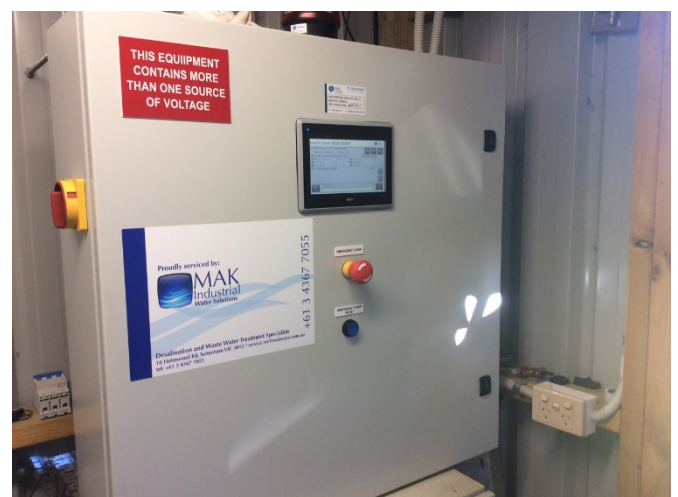
Internal view of the containerised SWRO plant
